# 1. St Thomas' Hospital – CFRP plates bonded to concrete

St Thomas' Hospital building North Wing located in Lambeth, London, is a 13-storey reinforced concrete building built in the 1970's.

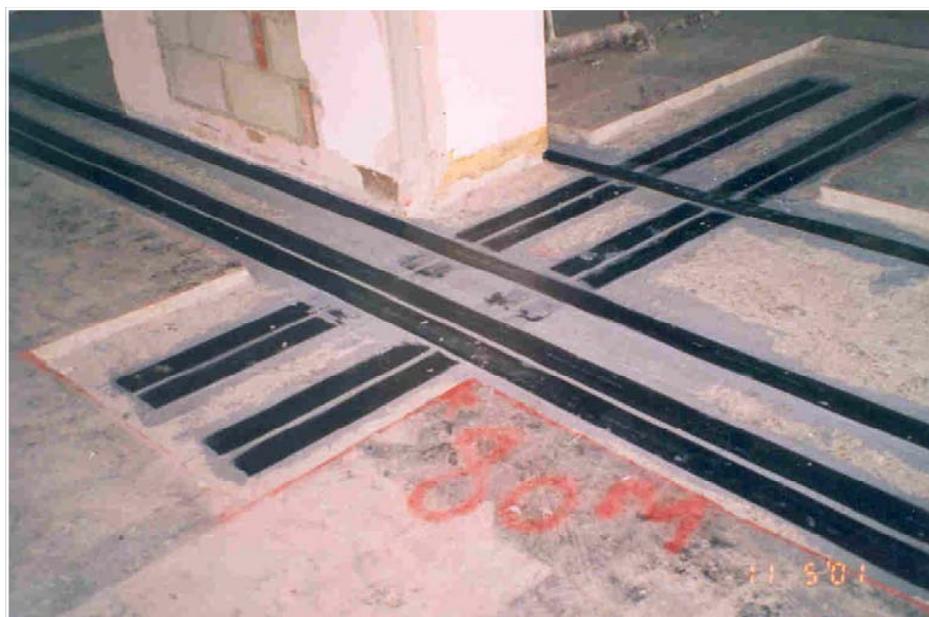
Tap testing of the bonded regions were continuously undertaken as the CFRP installation proceeded. In one instance a region was found have voids and resin-injection into the voids was undertaken and the region retested (in accordance with Steps 14 - 15 - 14 on the design activities flow chart).

CFRP installation was completed in accordance with the specification and method statements. TGP witnessed the first batch of strips installed, and two other randomly selected installations, but the majority of strip installation was undertaken with the contractor completing the QA and QC required.
