8. QAFCO Prill Tower – CFRP CFRP plates bonded to concrete

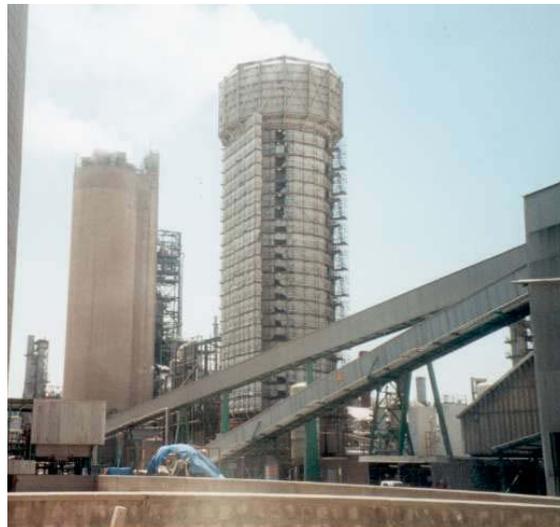
There are many locations of spalling of within the tower causing loss of section and further horizontal cracking.

The analysis of the tower showed that it had insufficient strength to carry the horizontal (hoop) bending for the daily thermal loading.

Figure 1. The Prill tower, shrouded with sheeting to control the bonding environment

The thermal gradient across the reinforced concrete walls of the structure was approximately 31 °C (internal temp > 70 °C), which was assumed to be the main loading case that was either excluded or underestimated in the original structure design, causing the structure to be understrength.

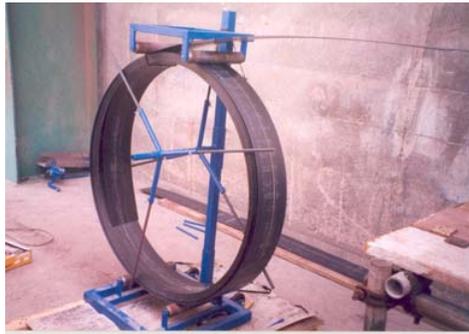
Figure 2. CFRP Material Roll

Pultruded laminates were chosen as the manufacturing method, as it was also critical to minimise the installation period. The materials chosen were manufactured by Degussa Feb MBT; laminates were 1.8mm thick, 160mm wide on 250m long rolls. A special modified adhesive was selected based on liaison with the material manufacturer, to ensure adequate working time and performance of the adhesive at the high installation temperatures. The laminates had a peel ply to minimise working time and to ensure a good quality bond.

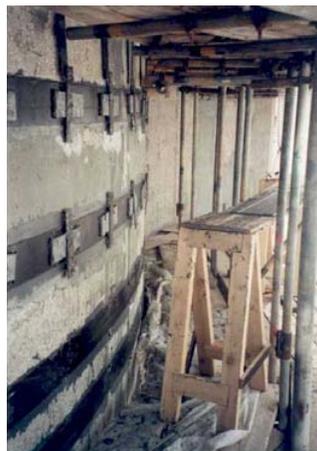
Figure 3. The proposed method of securing the laminates to the tower whilst the adhesive cured

The Method Statement detailed how the bonding environment was to be maintained, the lengths of laminate to be cut, techniques for performing this, how the laminates and surface were to be prepared and how to support the laminates during the curing of the adhesive. Additional points within the method statement detailed remedial works that can be performed if adhesive voids are discovered.

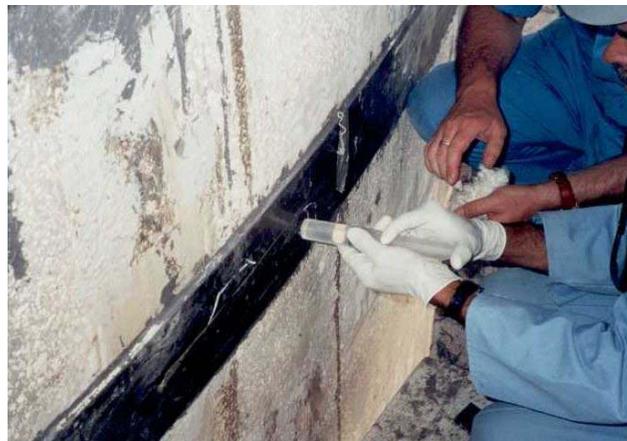
Figure 4. Checking and repairing voids

Tests were performed on the adhesive T_g , tensile modulus and strength in addition to requesting the manufacturer to supply characteristic values of tensile modulus and strength of the laminates. The laminates were tap tested and any voids exceeding the limits set within the specification were repaired.

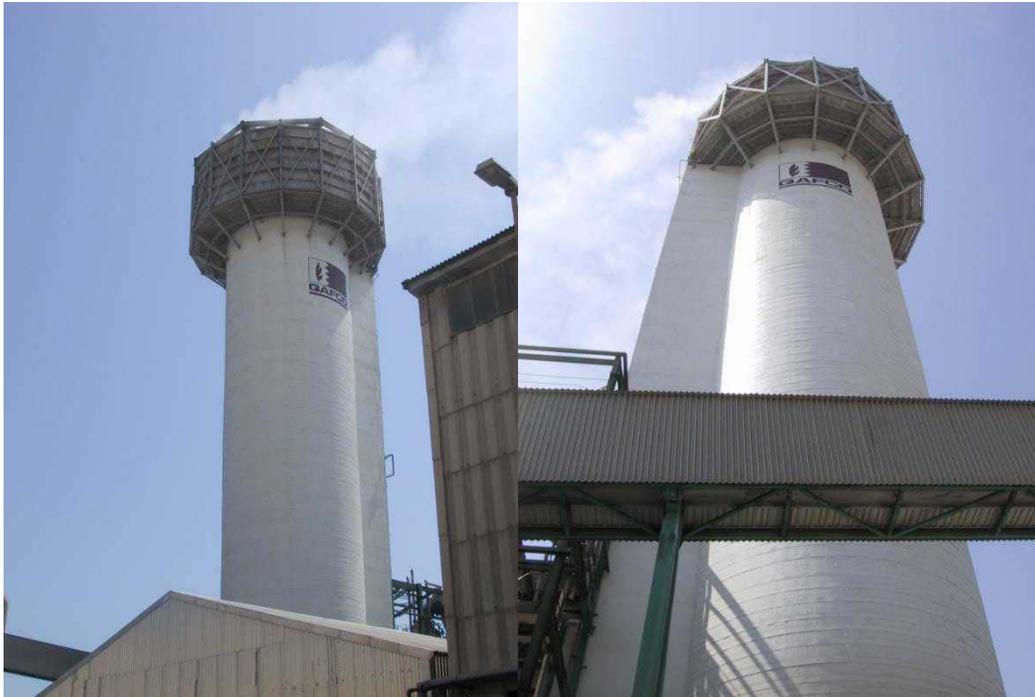
Figure 5. Strengthened and painted Prill tower

Further works were carried out on the concrete in the tower in the following year to ensure that the structure could continue operating. The tower was then painted to protect the laminates from direct UV and to ensure that the finished product was well presented.
