# 1. St Thomas' Hospital – CFRP plates bonded to concrete

St Thomas' Hospital building North Wing located in Lambeth, London, is a 13-storey reinforced concrete building built in the 1970's.

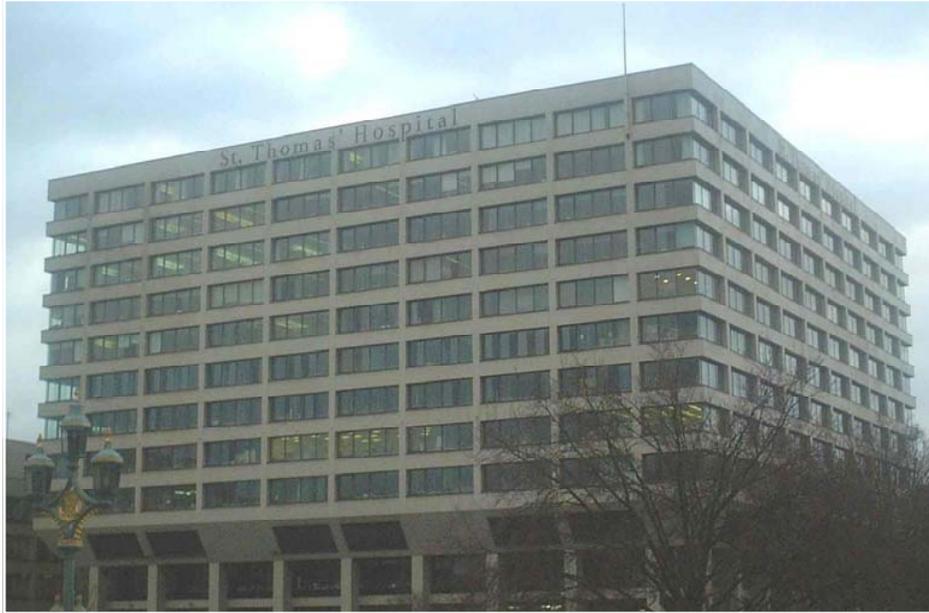
The reinforced concrete hospital building was undergoing major refurbishment to three floors, which included the introduction of many more services penetrations through existing concrete slabs, especially near columns (i.e. in hogging regions). The use of CFRP strengthening to replacement cut existing reinforcement allowed holes to be cut without locating or avoiding existing reinforcing bars.
