2. Trenchard Street Multi-Storey Car Park – CFRP near-surface-mounted reinforcement

Trenchard Street multi-storey car park is a reinforced concrete frame structure owned and operated by Bristol City Council in which some portions of cantilever slabs required strengthening. Since the slab surface was directly trafficked, conventional surface-mounted plate bonding could not be used and therefore 'near surface mounted' (NSM) reinforcement, in which bars are bonded into chases in the concrete surface was designed and installed.

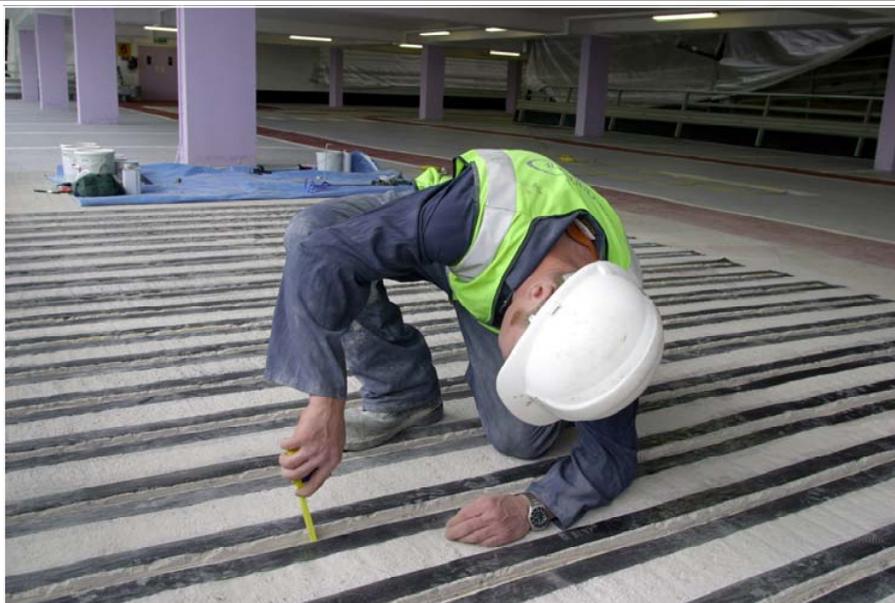
Surface preparation was by diamond sawing to form chase sides, and removing the concrete between saw cuts with light percussive tools. The designer witnessed the initial surface preparation to ensure that the methods were capable of producing the required surface, but thereafter the contractor completed his own QA inspections for the surface preparation, with occasional inspections from the client (Bristol City Council).

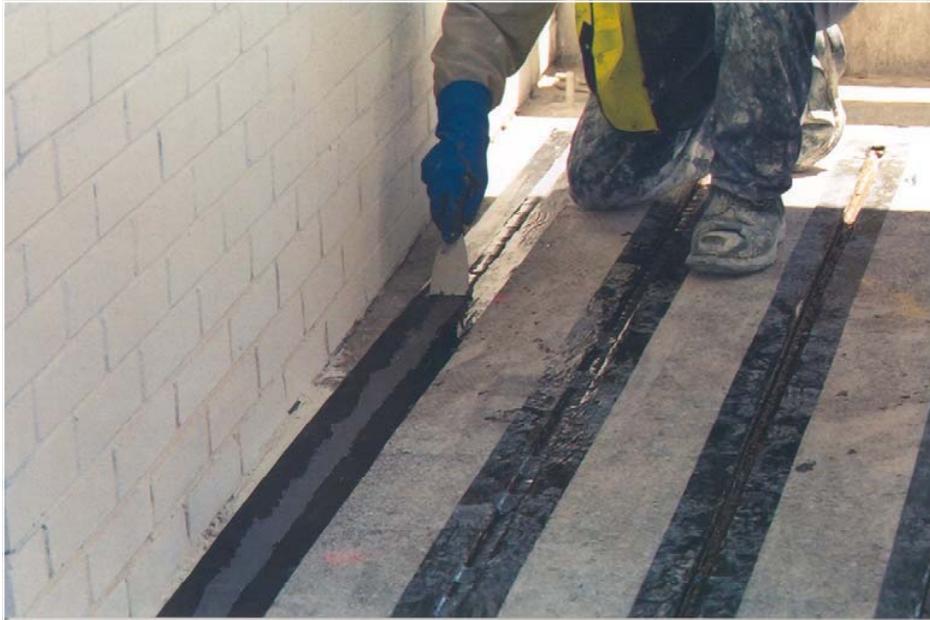
Installation was strictly in accordance with the approved method statement – chases were vacuumed, primer applied and allowed to become tacky, the chases part filled with adhesive, bars pressed into the adhesive, then the chases fully filled with further adhesive, taking care not to trap large air-bubbles between the adhesive layers. The contractor adopted refillable injection guns (as used for mastic application) to permit controlled and tidy dispensing of the adhesive in the precise quantity and location required.

As for surface preparation, TGP (the designer) witnessed the initial bar installation, after which the contractor completed their own QA processes with occasional inspections by the client.

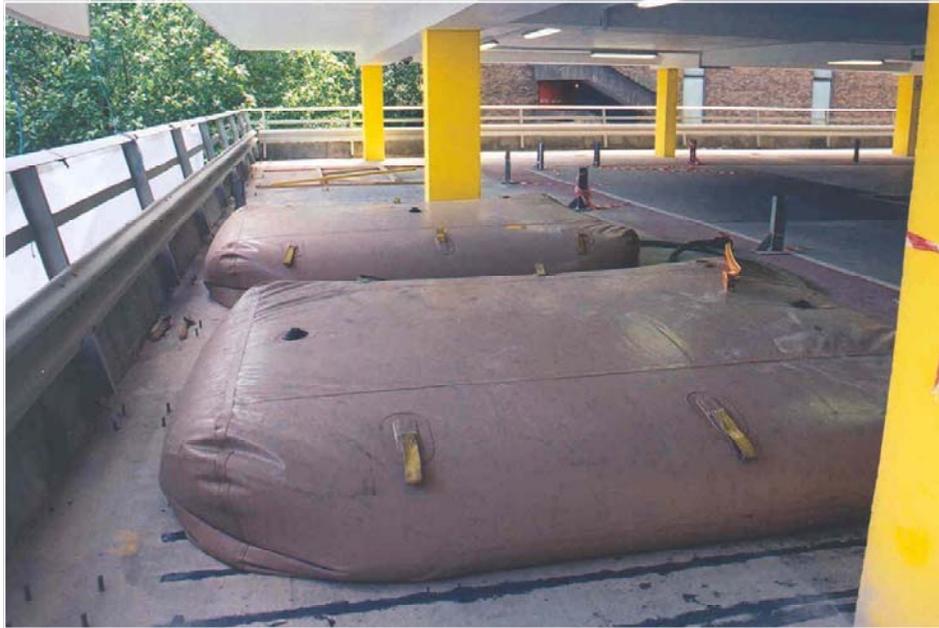
Due to the uniqueness of this project at the time of the works (the first application of NSM fibre-composite reinforcement in the UK), the strengthening scheme was subjected to load-test before and after strengthening. Two bays of cantilever slab were progressively loaded to 1.25 times service loading using large water-bags while monitoring deflections in several locations along the cantilever tip in the loaded and adjacent bays.

Matrix Solutions carried out the test under supervision by TGP, the load being progressively applied then removed over the course of 10 hours.

Acceptance criteria for the strengthening were previously defined in terms of absolute value of deflections under service load measured at tip of cantilever and a demonstrated increase in the stiffness of the structure, which was taken to indicate that the applied strengthening was carrying load. The results show that the stiffness under service loading increased by around 30%.
