4. Ealing Road Bridge – CFRP resin wrap and plates bonded to concrete

Introduction

Ealing Road Bridge is a reinforced concrete portal frame bridge carrying the A4005 over the Grand Union Canal in north London. The deck was strengthened with fibre composites in both sagging and hogging and the abutments were strengthened by the addition of a new reinforced concrete fascia.

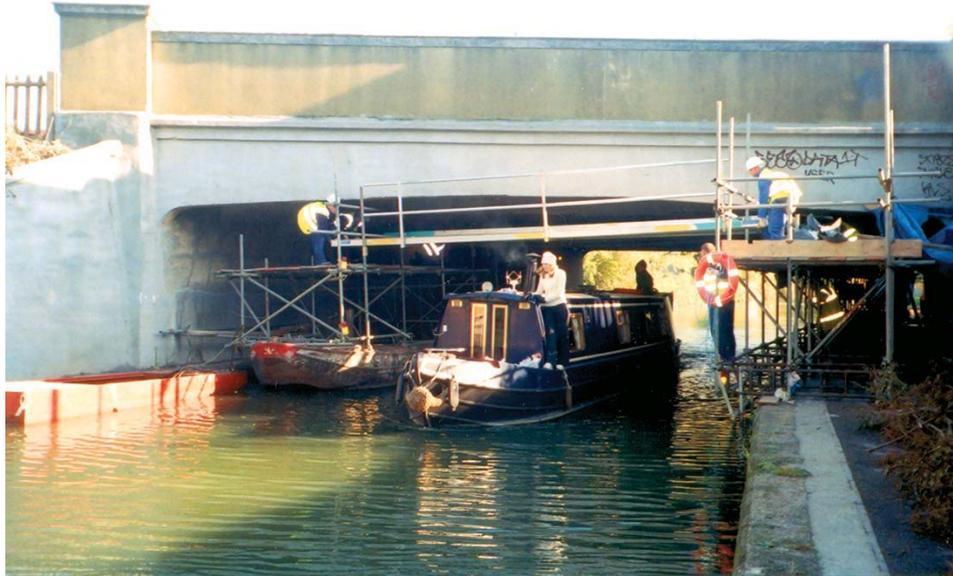
Outline example methods of working (including traffic management schemes and access platform operational specifications) were developed by TGP, and approval in principle was obtained from British Waterways and the Metropolitan Police. The compromise on sequencing adopted was that works over the deck (in the roadway) would commence at the start of the school holidays, and works beneath would commence in September. Since works beneath were outside the normal winter maintenance period, the soffit access platform would be demountable and allow the passage of canal boats within 30 minutes of their arrival at the bridge.

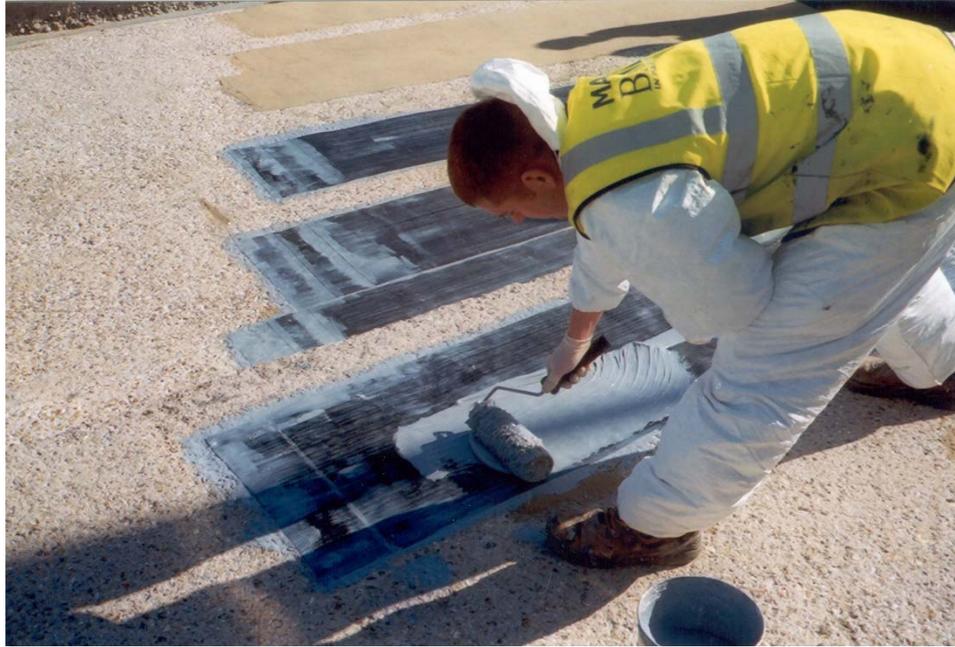
**Step 13.
Application of composite materials system**

Installation was strictly in accordance with the approved Method Statements.

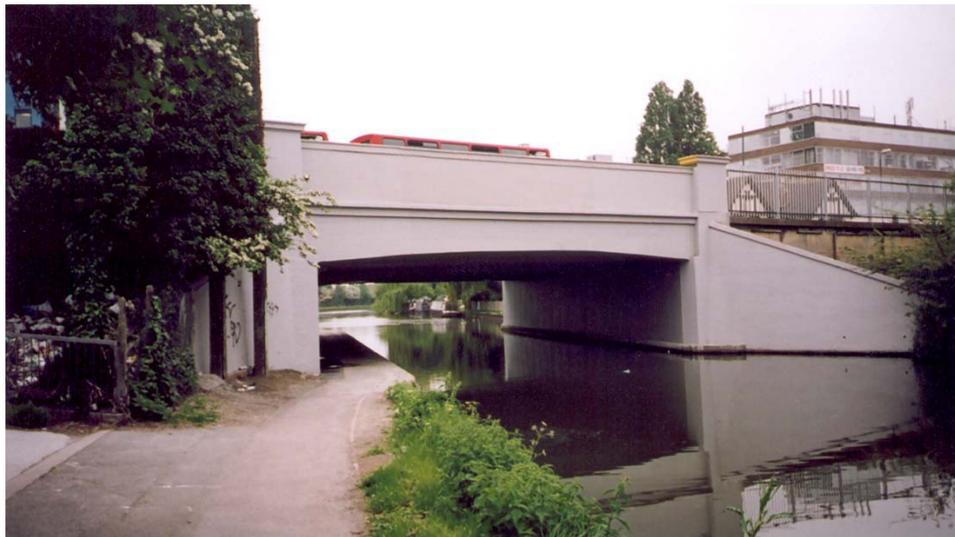
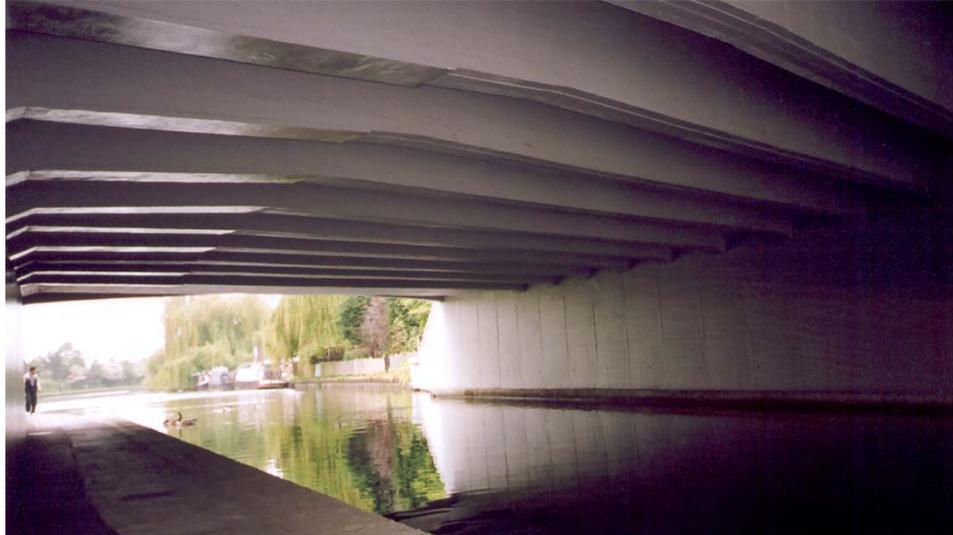
**Step 14.
Final QA checks, inspection and approval**

Since TGP (as designer) supervised all the works and bi-weekly progress meetings addressed technical matters as the contract progressed, there was no separate inspection and approval process.
